**Flood Control Project Maintenance
Levee Inspections**
LMA District Cover Sheet
Spring 2017 Levee Inspection Results

Reclamation District No. 0563 Tyler Island

Unit Cover Sheet

| Waterway | | | Bank | Unit Miles |
|---|---|---|---|---|
| Unit No. 01 Georgiana Slough (Tyler Island) | | | Left | 12.11 |

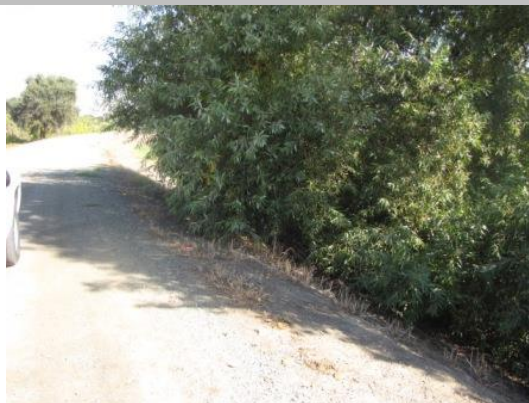
Photo 2 of 2 : SP_2017_RD0563_210_68_20170313_00054.jpg

Looking southeast at dense trees on landside slope and toe.

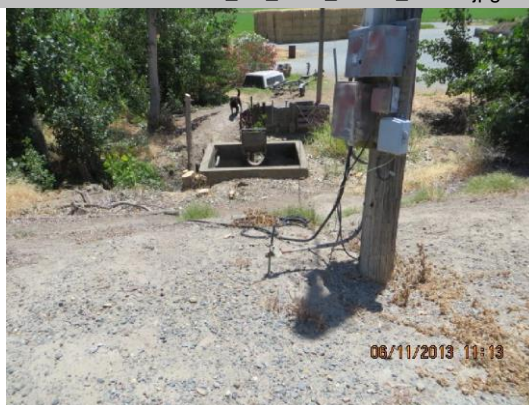
Photo 1 of 2 : UCIP_SP_2017_14887_24550.jpg

| FS_ID:14887 DS_ID:20140 EP_NO: 12708 Repair Type: Non-Urgent Crossing Status: Found UCIP Comments: Pipe heavily corroded. Good candidate for viewo inspection. FIELD_STRUCT_DESC: 1 of 2: 14-inch pipe through levee 3.0 feet below crown. Slant pump and gate valve on waterward side. 9'X7' concrete distribution box on LS toe. Service pole on landward shoulder (Permit No. 12708, 1980). Replaced 8-inch pipe under Permit No. 11211 and 1954 O&M manual. FS Date: 6/11/2013 | | | | | |

Distribution box and JP on LS.

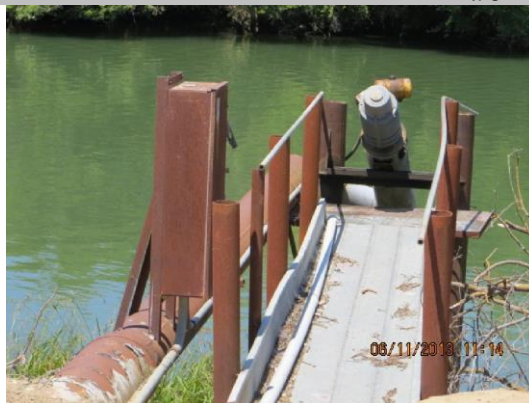
Photo 2 of 2 : UCIP_SP_2017_14887_24549.jpg

Pump and walkway on WS.

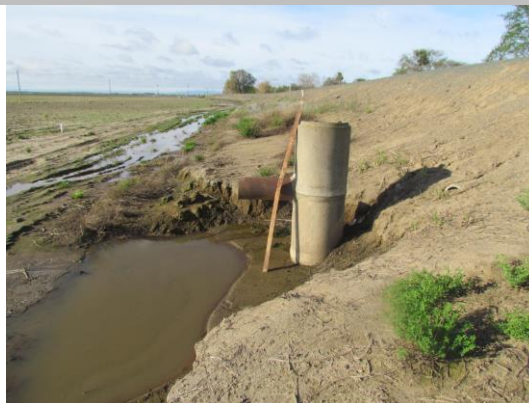
Photo 1 of 4 : SP_2017_RD0563_210_125_20170316_00253.jpg

Looking at erosion around stand pipe at landward toe.

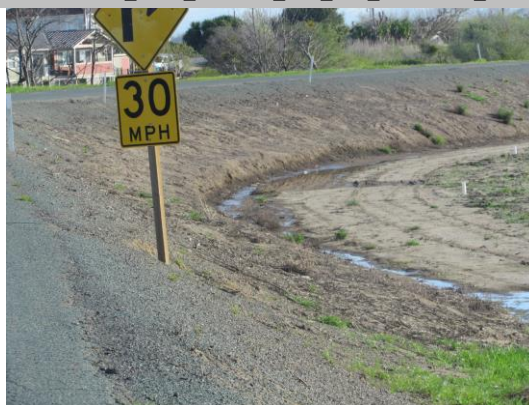
Photo 2 of 4 : SP_2017_RD0563_210_125_20170316_00254.jpg

Looking west at cut along farm's service road at landward toe and berm.

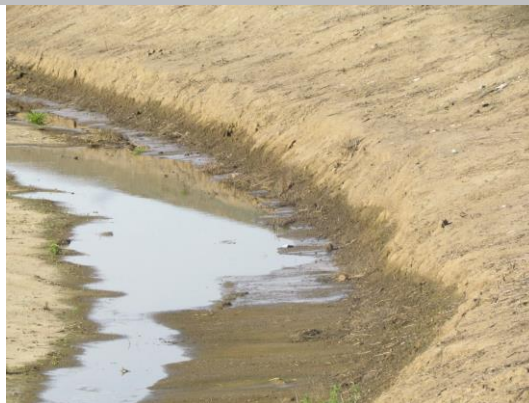
Photo 4 of 4 : SP_2017_RD0563_210_125_20170316_00255.jpg

| Six to twelve inch cut along the landward toe. | | | | | | |

Looking south at cut along farm's service road at landward toe.

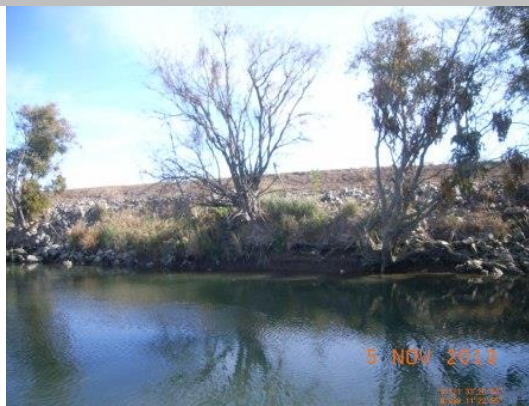
Photo 1 of 1 : SP_2017_RD0563_210_38_20170313_00031.jpg

| 1997 - Narrow eroding berm upstream of existing rock. 2001 - Staked, low fascine walls at bankline. 2011 - Minor new erosion. Site extended downstream. 2012 - Rock repair failing in one erosion pocket. 2015: Last observed in 2013. [2015 Site ID: GEO_8-3_L] | | | | | |

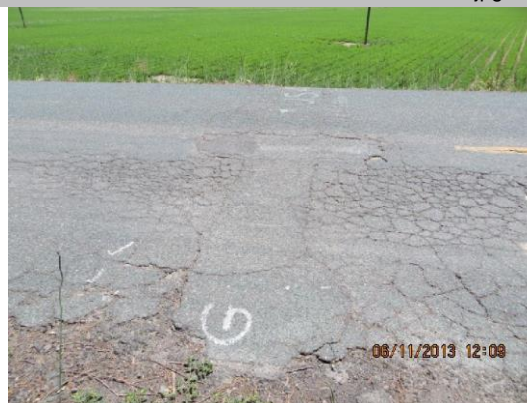
Photo 1 of 3 : UCIP_SP_2017_16244_27390.jpg

Cut in pavement with USAA markings for gasoline.

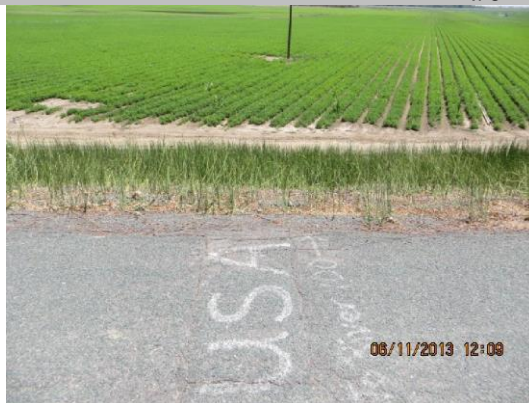
Photo 2 of 3 : UCIP_SP_2017_16244_27389.jpg

Cut in pavement with USAA markings for gasline.

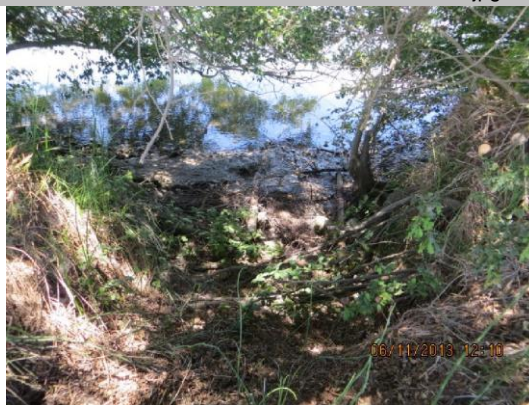
Photo 3 of 3 : UCIP_SP_2017_16244_27388.jpg

Pipe visible on WS toe.

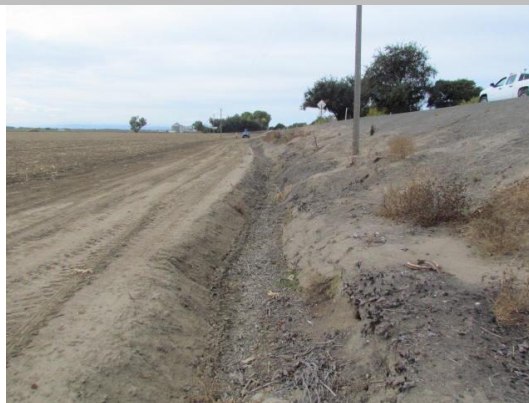
Photo 1 of 1 : SP_2017_RD0563_210_93_20170313_00095.jpg

Looking south at irrigation ditch at landside toe.

| Ditch at landside toe should be removed. | | | | | |

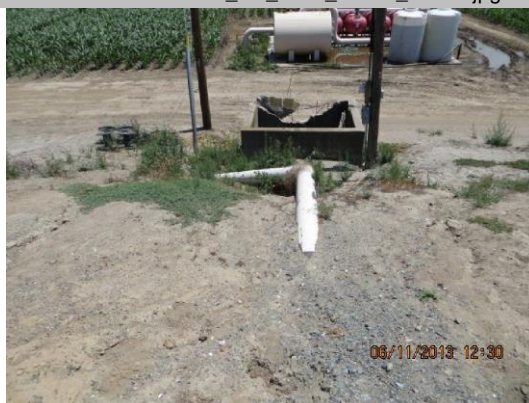
Photo 1 of 3 : UCIP_SP_2017_14927_24590.jpg

| FS_ID:14927 DS_ID:20145 EP_NO: 11205 Repair Type: Non-Urgent Crossing Status: Found UCIP Comments: Some settlement over pipe on WS shoulder and there is some animal burrow tunnels over the pipe on the LS shoulder. FIELD_STRUCT_DESC: 4 of 5: 10-inch pipe through levee 3.8 feet below crown. Siphon breaker on landward shoulder. Slant pump off WS toe. Booster and filter station off LS toe. Abandoned concrete distribution box at LS toe. 1-inch galvanized iron electrical conduit at same location (ABO No.11205, 1971). Originally included in the 1954 O&M manual. FS Date: 6/11/2013 | | | | | |

Pipe, distribution box, JP, electrical conduit, and booster/filter system on LS.

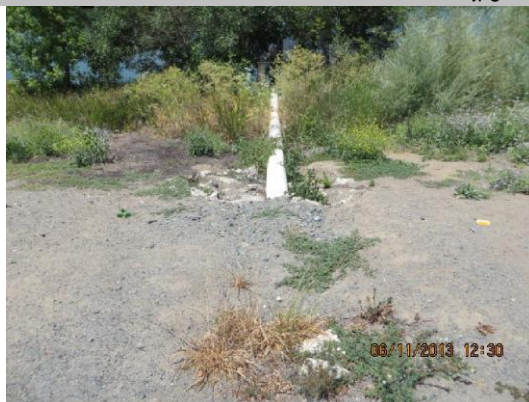
Photo 2 of 3 : UCIP_SP_2017_14927_24589.jpg

Pipe on WS slope.

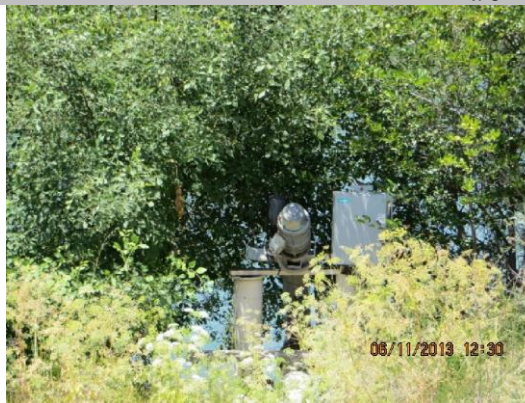
Photo 3 of 3 : UCIP_SP_2017_14927_24588.jpg

Slant pump off WS toe.

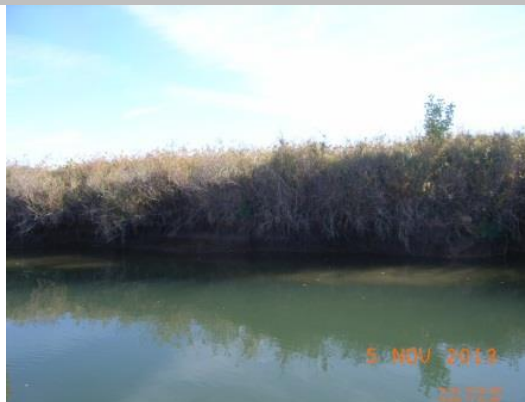
Photo 1 of 1 : SP_2017_RD0563_210_45_20170313_00038.jpg

| 2009 - Small scallops of erosion into the levee toe behind brush boxes. 2011 - Minor new erosion. 2012 - Site extended upstream to account for addition erosion pockets. 2015: Last observed in 2013. [2015 Site ID: GEO_7-2_L] | | | | | |

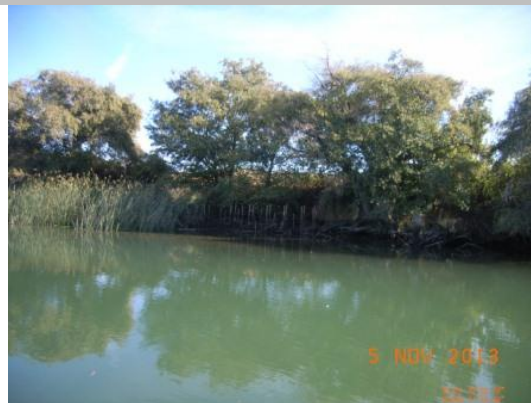
Photo 1 of 1 : SP_2017_RD0563_210_46_20170313_00039.jpg

| 1997 - Deep pockets of erosion into a narrow berm just downstream of the rock. 2000 - Scallops in banks with small colored flags, some new biotech rolls in with older rolls in the scallops. 2001 - Staked , low fascine walls at the bankline. 2011 - Site upgraded to CRITICAL. Site extended upstream due to new erosion pocket. New tree popouts and new erosion. 2013 - Pipe observed at upstream end of site. 2015: Last observed in 2013. [2015 Site ID: GEO 6-8 L] | | | | | |

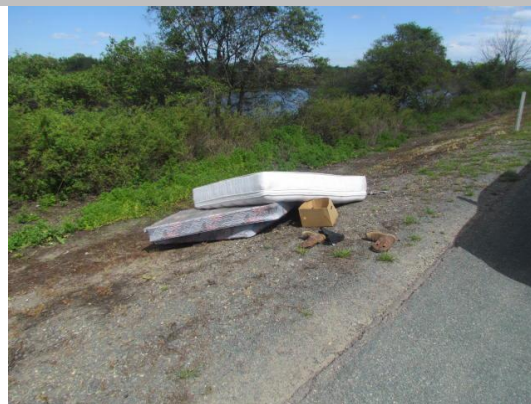
Photo 1 of 1 : SP_2017_RD0563_210_163_20170313_00137.jpg

| Garbage on waterward slope. | | | | | |

Looking west at garbage on waterward slope.

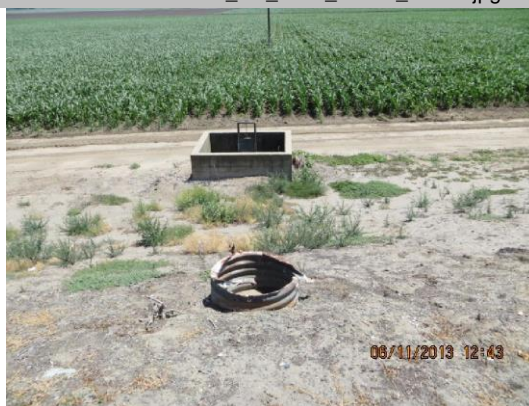
Photo 1 of 3 : UCIP_SP_2017_14943_24595.jpg

| FS_ID:14943 DS_ID:20146 EP_NO: 11205 Repair Type: Non-Urgent Crossing Status: Found UCIP Comments: Need to verify wether or not pipe has been abandoned. FIELD_STRUCT_DESC: 5 of 5: 8-inch pipe through levee 3.7 feet below crown. Pump and gate valve on waterward end. Siphon breaker on landward shoulder. (ABO No. 11205, 1971). Originally included in 1954 O&M manual with the description 1" air valve, brass cock and cover, reinforced concrete spillbox. FS Date: 6/11/2013 | | | | | |

Distribution box and 24-inch CMP riser on LS slope.

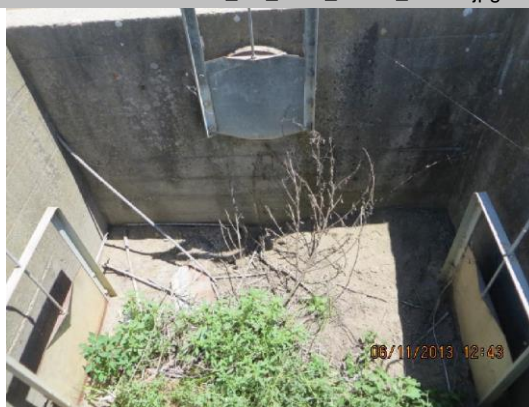
Photo 2 of 3 : UCIP_SP_2017_14943_24594.jpg

Inside distribution box at LS toe.

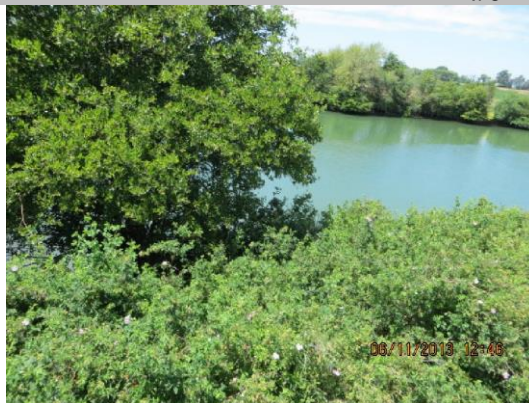
Photo 3 of 3 : UCIP_SP_2017_14943_24593.jpg

Unable to locate pump or other appurtances on WS toe due to vegetation.

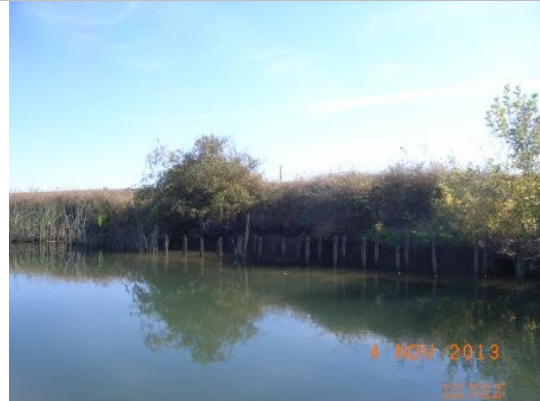
Photo 1 of 1 : SP_2017_RD0563_210_55_20170313_00044.jpg

| 1997 - Deep pockets of erosion and narrow berm. Reach is characterized by lots of pockets into the existing berm and/or levee slope. 1999 - Some pockets filled with rock riprap. 2000 - Exposed fabric. 2001 - Staked, low fascine walls at bankline. 2002 - New spot of rock at upstream end. Some new brush boxes. 2005 - Some stone sliding off the underlying geotextile fabric. Some new brush bundles in the brush boxes; some with missing bundles. Some boxes too low relative to high tide. 2009 - Minimal new erosion, site length extended. 2010 - New erosion on downstream end, site extended downstream. 2011 - Sites 6.1, 6.4 and 6.6 were combined. New erosion pockets, site extended to include the erosion in between the old sites. 2012 - Rock has been placed in portions of the bank since last year. 2015: Last observed in 2013. [2015 Site ID: GEO_6-3_L] | | | | | |

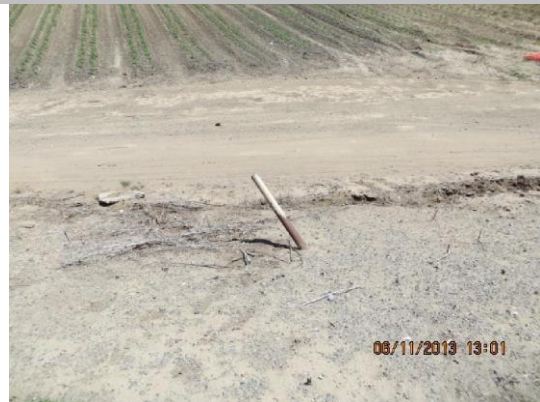
Photo 1 of 2 : UCIP_SP_2017_16289_27439.jpg

| FS_ID:16289 DS_ID:20148 EP_NO: 1826 Repair Type: Non-Urgent Crossing Status: Found UCIP Comments: Pipe abandoned and should be done so properly. FIELD_STRUCT_DESC: *ABANDONED* 2-inch discharge pipe through levee 2.7 feet below crown (Permit No. 1826, 1959). FS Date: 6/11/2013 | | | | | |

Pipe visible on LS slope.

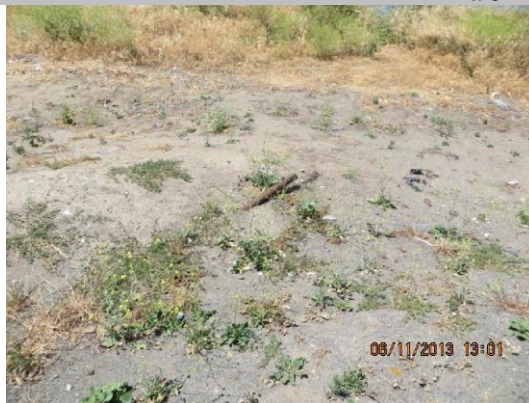
Photo 2 of 2 : UCIP_SP_2017_16289_27438.jpg

Pipe visible on WS shoulder.

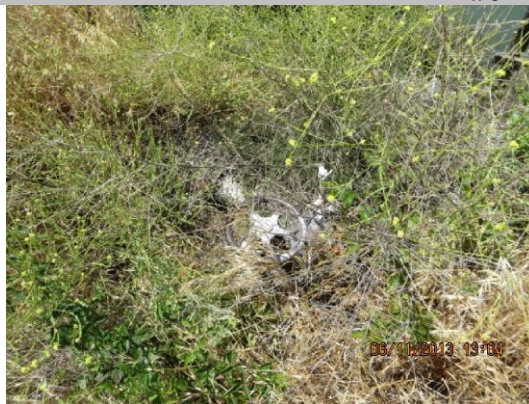
Photo 1 of 3 : UCIP_SP_2017_14949_24603.jpg

Slide gate at pump on WS slope

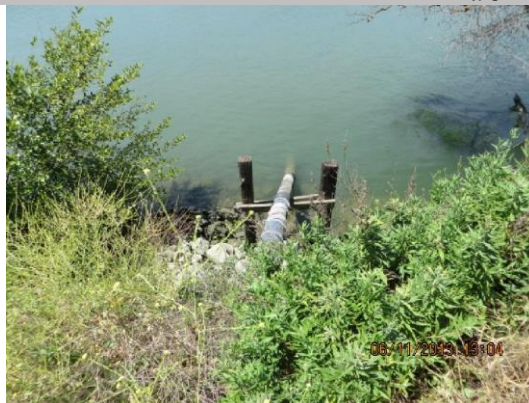
Photo 2 of 3 : UCIP_SP_2017_14949_24602.jpg

Pipe at WS toe.

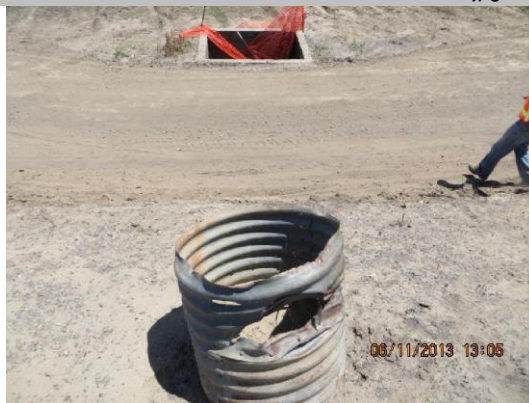
Photo 3 of 3 : UCIP_SP_2017_14949_24601.jpg

Siphon breaker in 24-inch CMP riser on LS shoulder.

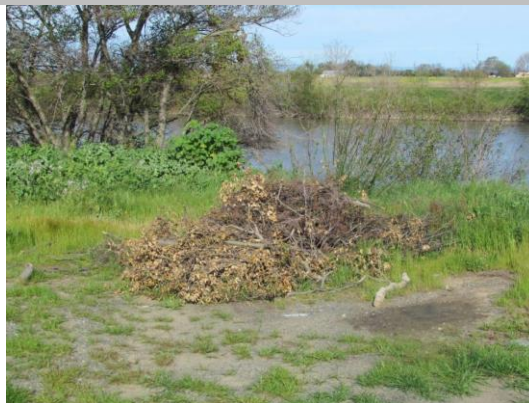
Photo 1 of 1 : SP_2017_RD0563_210_126_20170316_00256.jpg

| Prunings stock pile on waterward slope and berm. | | | | | |

Looking west at small pruning pile on waterward slope.

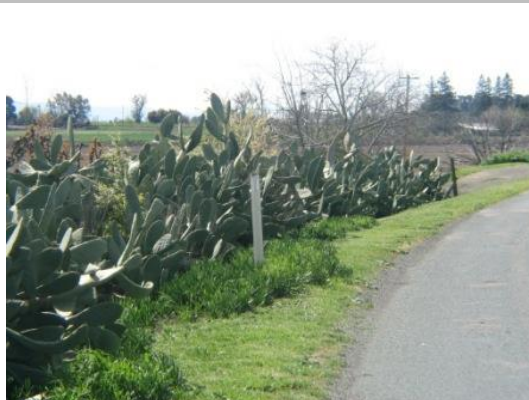
Photo 1 of 2 : SP_2017_RD0563_210_22_20170313_00018.jpg

| Large cactus on landward slope. | | | | | |

Large cactus plant on landward slope from LM 6.04 to 6.08

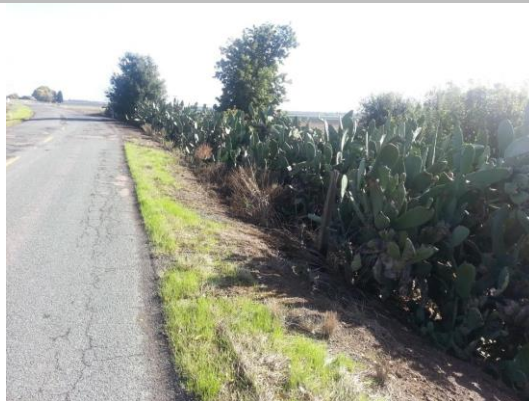
Photo 2 of 2 : SP_2017_RD0563_210_22_20170313_00019.jpg

Looking downstream at dense cactus on landward slope. (Fall 2016)

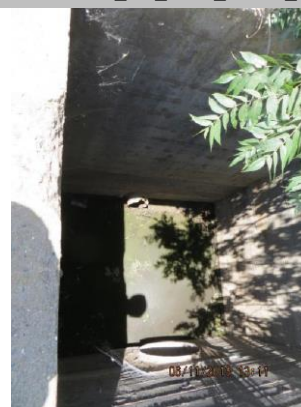
Photo 2 of 3 : UCIP_SP_2017_14950_24606.jpg

| FS_ID:14950 DS_ID:20149 EP_NO: 11206 Repair Type: Non-Urgent Crossing Status: Found UCIP Comments: Need to install a CMP riser on LS shoulder to protect the vent/filler pipe. FIELD_STRUCT_DESC: 2 of 2: 10-inch steel irrigation siphon through the levee 4.8 feet below the crown. Vent/filler pipe on LS shoulder. 7'X9' concrete distribution box on LS toe (ABO No. 11206, 1971). Originally included in 1954 O&M manual with the description 2" air and primer valve, reinforced concrete spillbox. FS Date: 6/11/2013 | | | | | |

Outlet pipe in distribution box on LS toe.

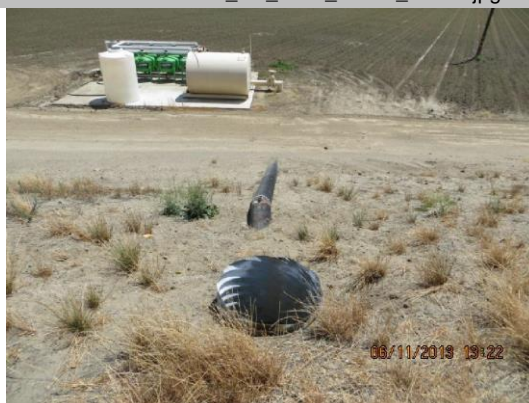
Photo 2 of 3 : UCIP_SP_2017_14963_24621.jpg

Siphon breaker in 24-inch CMP riser on LS shoulder.

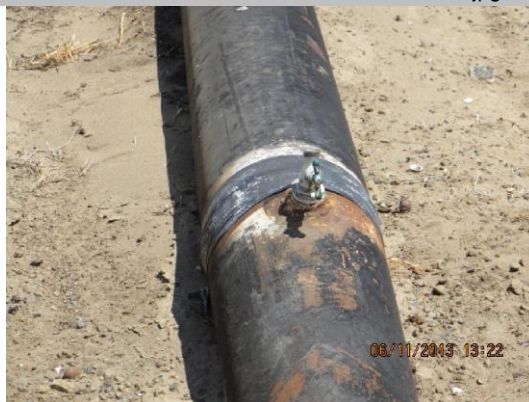
Photo 3 of 3 : UCIP_SP_2017_14963_24620.jpg

Vent/filler pipe on LS slope.

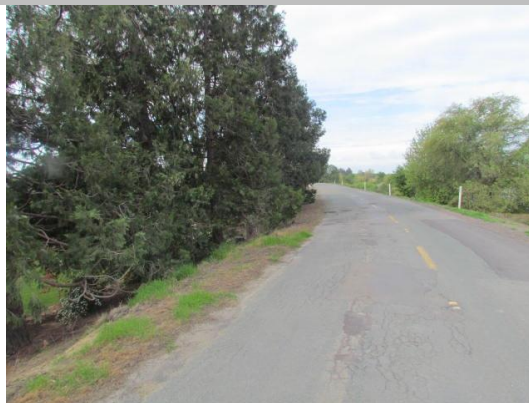
Photo 1 of 1 : SP_2017_RD0563_210_23_20170313_00020.jpg

Looking south at trees on landward shoulder.

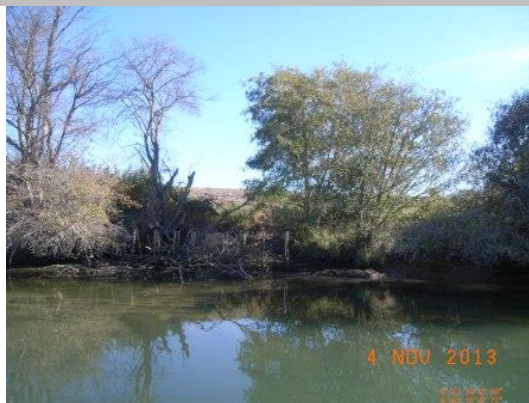
Photo 1 of 1 : SP_2017_RD0563_210_44_20170313_00037.jpg

| 2013 - Erosion pockets into the levee prism. Erosion pockets primarily located behind unmaintained brush boxes. 2015: Last observed in 2013. [2015 Site ID: GEO_5-8_L] | | | | | |

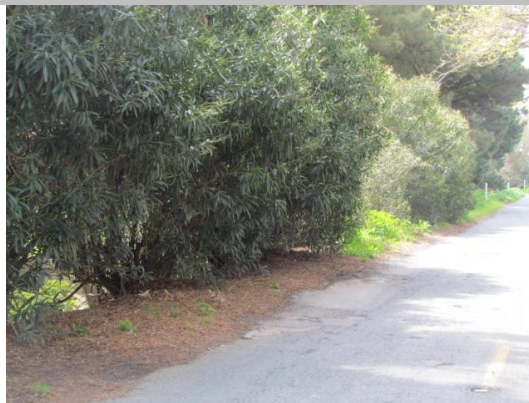
Photo 1 of 1 : SP_2017_RD0563_210_25_20170313_00021.jpg

Looking southeast at dense landscaping on landside shoulder and slope.

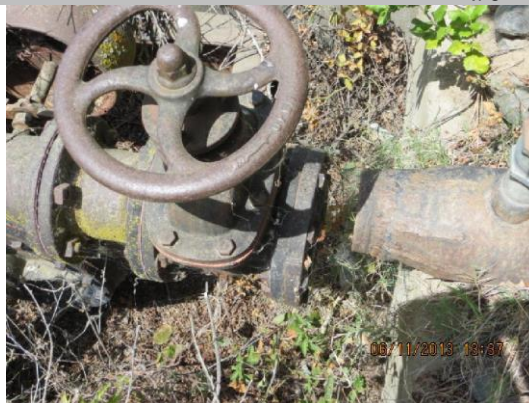
Photo 1 of 3 : UCIP_SP_2017_14966_24628.jpg

| FS_ID:14966 DS_ID:20152 EP_NO: 11201 Repair Type: Non-Urgent Crossing Status: Found UCIP Comments: Appears abandoned and should be done so properly. FIELD_STRUCT_DESC: 3 of 3: 8-inch pipe through levee 4.7 feet below crown. Pump and gate valve on waterward berm. 4-foot diameter concrete standpipe on LS toe. Y-ramp on waterward slope (ABO No. 11201, 1971). Originally included in the 1954 O&M manual. FS Date: 6/11/2013 | | | | | |

No connection to pump on WS shoulder.

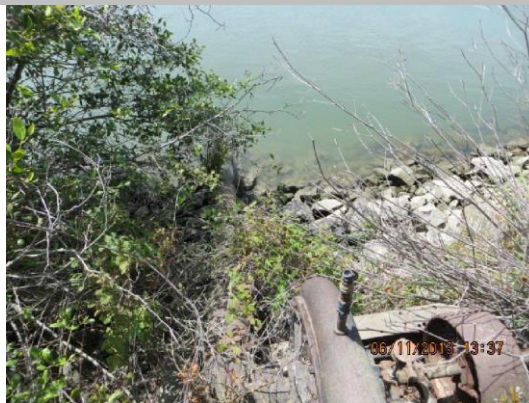
Photo 2 of 3 : UCIP_SP_2017_14966_24627.jpg

Pump and pipe on WS slope.

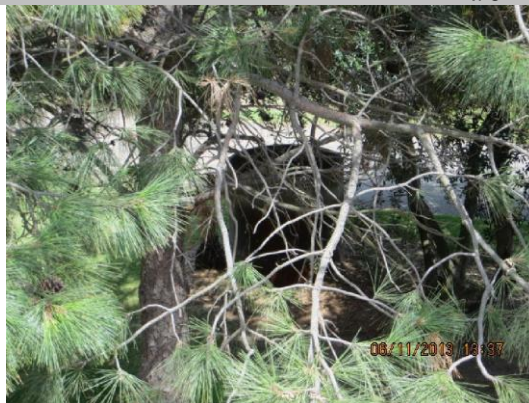
Photo 3 of 3 : UCIP_SP_2017_14966_24630.jpg

4-foot concrete standpipe on LS toe.

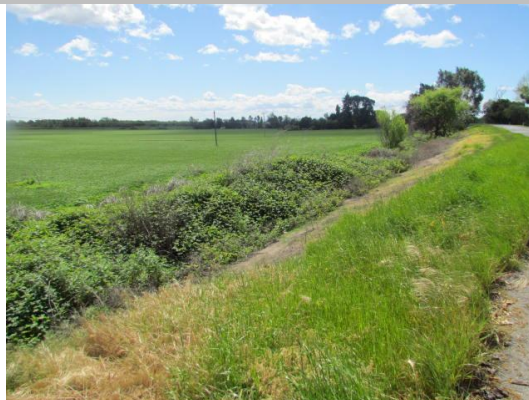
Photo 1 of 1 : SP_2017_RD0563_210_164_20170313_00138.jpg

| Dense vegetation (vines) at landward toe. | | | | | |

Looking east at dense vegetation (vines) at landward toe.

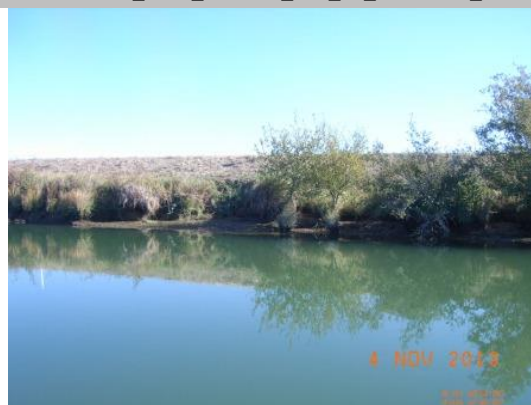
Photo 1 of 1 : SP_2017_RD0563_210_51_20170313_00042.jpg

| 1997 - Pocket erosion into the toe of the levee. 2000 - Scallops in banks with small colored flags, biotech rolls present. 2001 - Staked, low fascine walls at bankline. 2003 - Still have visibly bad spots, especially at the upstream end. 2005 - Some new brush bundles in the brush boxes; some with missing bundles. Some boxes too low relative to high tide. 2010 - Site extended upstream. 2011 - Minor new erosion. 2015: Last observed in 2013. [2015 Site ID: GEO_5-3_L] | | | | | |

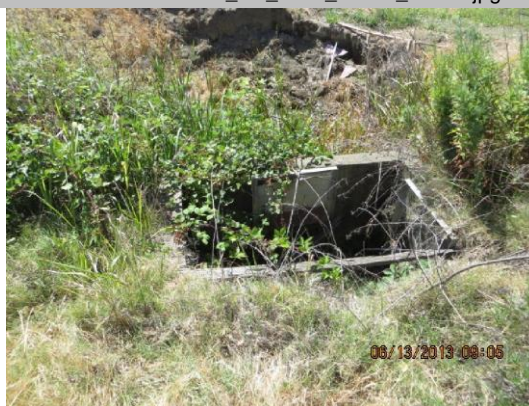
Photo 1 of 3 : UCIP_SP_2017_40790_24633.jpg

7'X9' concrete distribution box on LS toe.

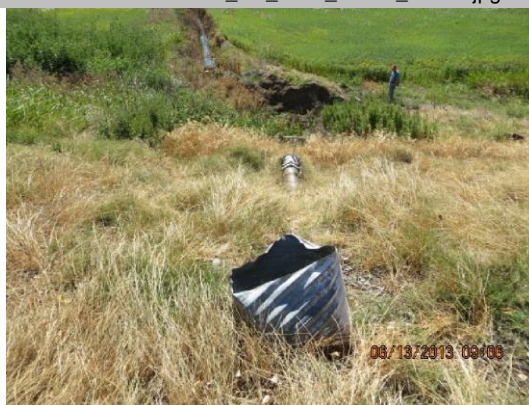
Photo 2 of 3 : UCIP_SP_2017_40790_24632.jpg

24-inch CMP standpipe with vent/filler pipe on LS shoulder.

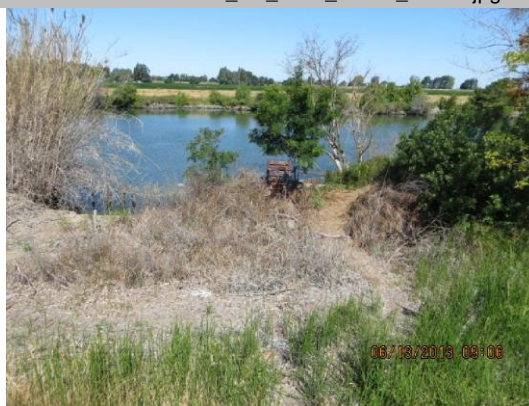
Photo 3 of 3 : UCIP_SP_2017_40790_24631.jpg

Steel walkway support for pipe on WS toe.

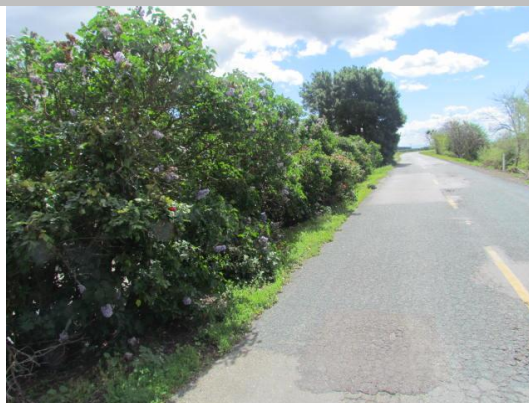
Photo 1 of 1 : SP_2017_RD0563_210_75_20170313_00063.jpg

| Dense landscaping on landward shoulder,slope and toe. | | | | | |

Looking south at dense landscaping on landward shoulder and slope.
(Spring 2016)

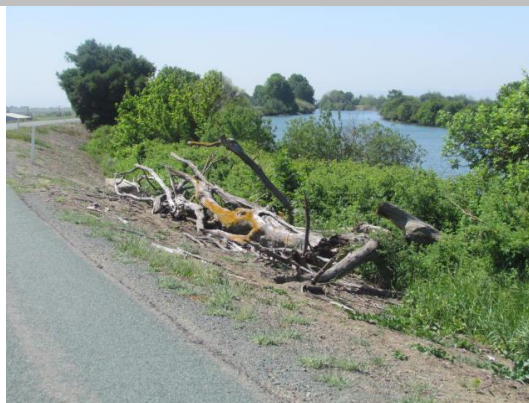
Photo 1 of 1 : SP_2017_RD0563_210_95_20170313_00096.jpg

Looking southwest at prunings on waterward slope.

| Prunings should be burned or removed from waterward slope. | | | | | |

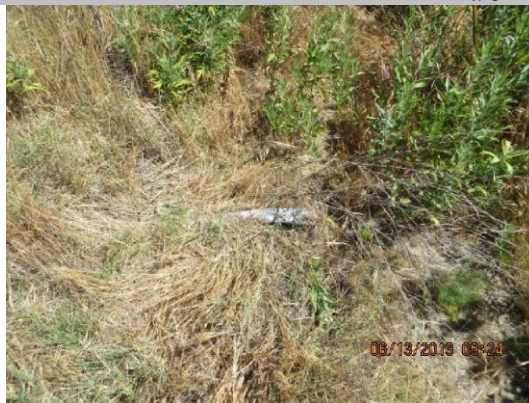
Photo 1 of 3 : UCIP_SP_2017_14968_24637.jpg

Steel parts on LS toe may indicate location of distribution box.

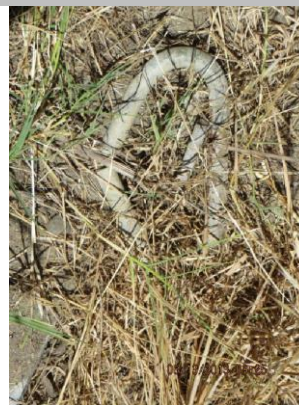
Photo 2 of 3 : UCIP_SP_2017_14968_24636.jpg

Steel parts on LS toe may indicate location of distribution box.

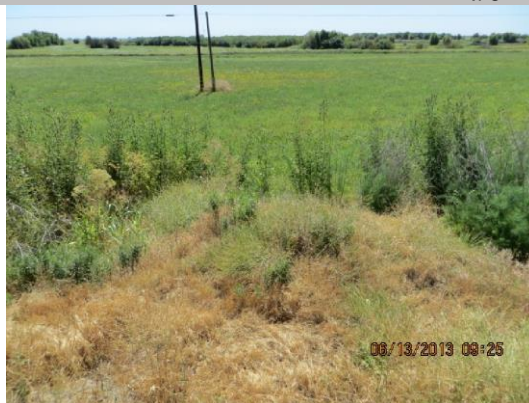
Photo 3 of 3 : UCIP_SP_2017_14968_24635.jpg

Wide berm on LS toe.

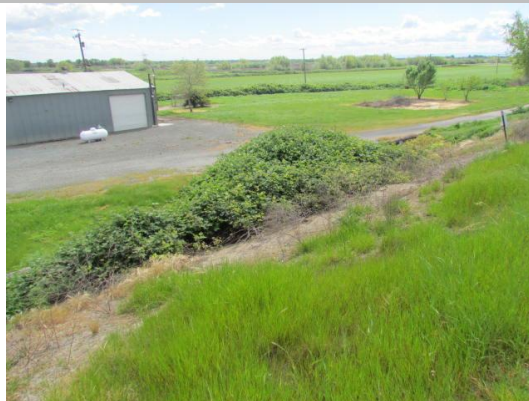
Photo 1 of 1 : SP_2017_RD0563_210_151_20170313_00133.jpg

| Dense berryvines at landward toe. | | | | | |

Looking southeast at dense vegetation at landward toe.

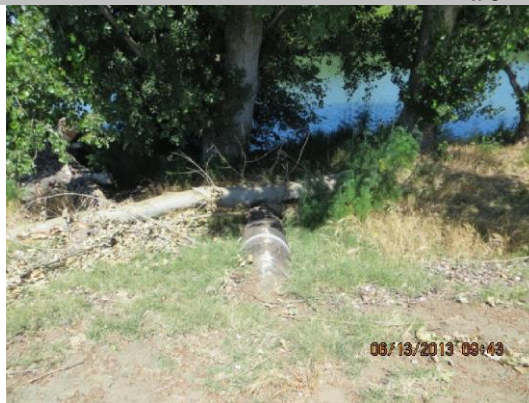
Photo 1 of 2 : UCIP_SP_2017_42743_24641.jpg

FS_ID:42743
DS_ID:20155
EP_NO: 11214
Repair Type: Non-Urgent
Crossing Status: Found
UCIP Comments: Good candidate for video inspection.
FIELD_STRUCT_DESC: 2 of 2: 24-inch steel irrigation siphon through the levee 0.5-feet below the crown. Vent and filler pipe on landward slope (ABO No. 11214, 1971). Originally included in the 1954 O&M manual.
FS Date: 6/13/2013

Pipe visible on WS slope.

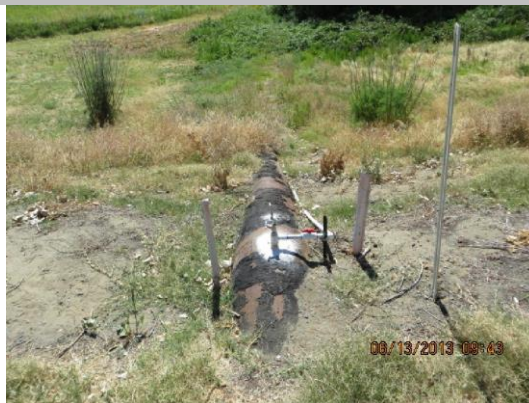
Photo 2 of 2 : UCIP_SP_2017_42743_24640.jpg

Pipe, vent, and filler valve on LS shoulder.

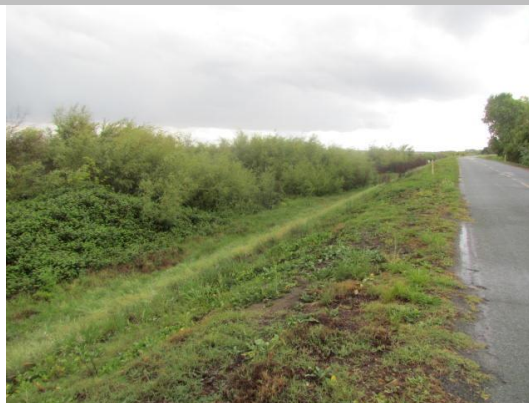
Photo 1 of 1 : SP_2017_RD0563_210_27_20170313_00023.jpg

| Dense vegetation at landward toe. | | | | | |

Looking southeast at dense vegetation within landward right away.

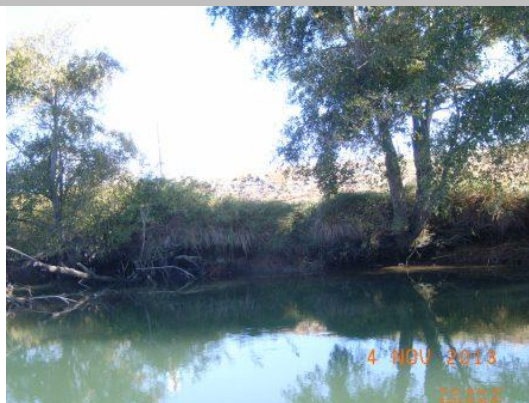
Photo 1 of 1 : SP_2017_RD0563_210_53_20170313_00043.jpg

| 1997 - Pocket erosion at upstream end and into the levee toe under the Alder trees. 2003 - New brush boxes with wattles on bank. 2004 - No brush boxes. 2005 - Site extended from the downstream side of the bridge. Whole bank is vertical. 2010 - Some minor new erosion. 2011 - Site upgraded to CRITICAL. New erosion pockets throughout the site. Sites 4.5, and 4.6 were combined. 2015: Last observed in 2013. [2015 Site ID: GEO_4-5_L] | | | | | |

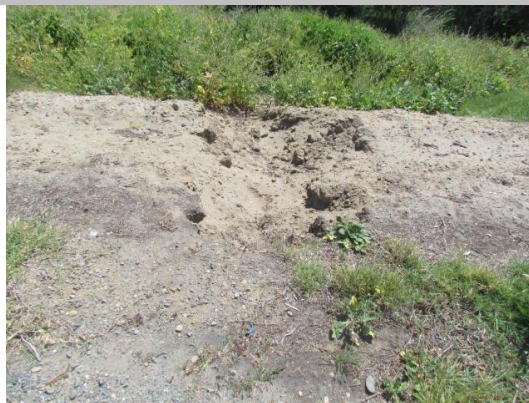
Photo 1 of 1 : SP_2017_RD0563_210_97_20170313_00098.jpg

| Minor erosion on landside shoulder and slope. | | | | | |

Looking east at slope erosion on landward shoulder and slope.

| S1 : Repair slope instability. | | | | | |

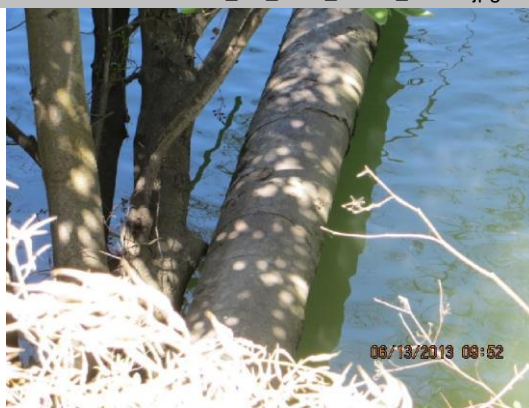
Photo 1 of 2 : UCIP_SP_2017_16304_27464.jpg

| FS_ID:16304 DS_ID:20185 EP_NO: N/A Repair Type: Non-Urgent Crossing Status: Found UCIP Comments: Slight depression in crown along pipe alignment may be indication of pipe internal failure. Good candidate for video inspection. FIELD_STRUCT_DESC: 14-inch pipe through levee 5.1 feet below crown. Originally included in the 1954 O&M manual. FS Date: 6/13/2013 | | | | | |

Pipe visible on WS toe.

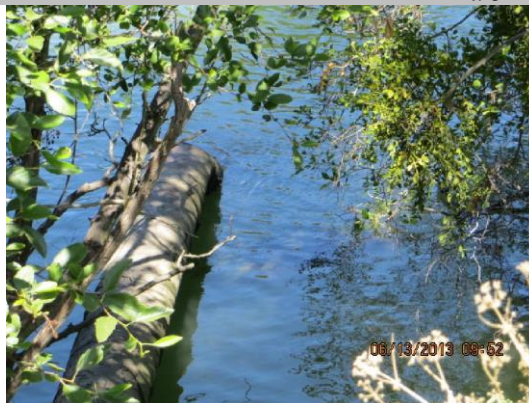
Photo 2 of 2 : UCIP_SP_2017_16304_27463.jpg

| UCIP Comments: Slight depression in crown along pipe alignment may be indication of pipe internal failure. Good candidate for video inspection. | | | | | | |

Pipe visible on WS toe.

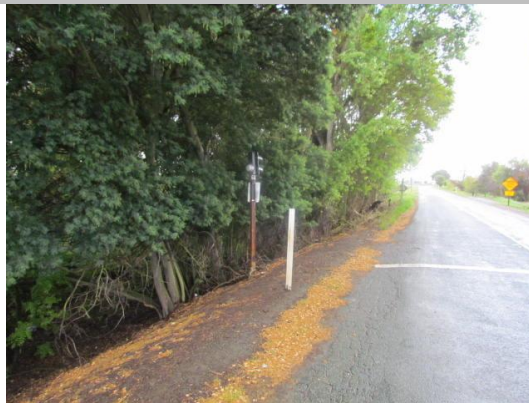
Photo 1 of 1 : SP_2017_RD0563_210_29_20170313_00025.jpg

| Dense (untrimmed) trees on landward slope. | | | | | |

Looking southeast at dense trees on landward slope and toe.

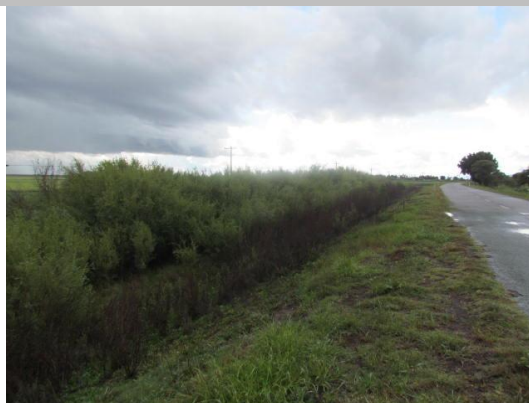
Photo 1 of 5 : SP_2017_RD0563_210_90_20170313_00087.jpg

| Berryvines and willows on landside toe. | | | | | |

Looking southeast at dense vegetation at landward toe. (Spring 2015)

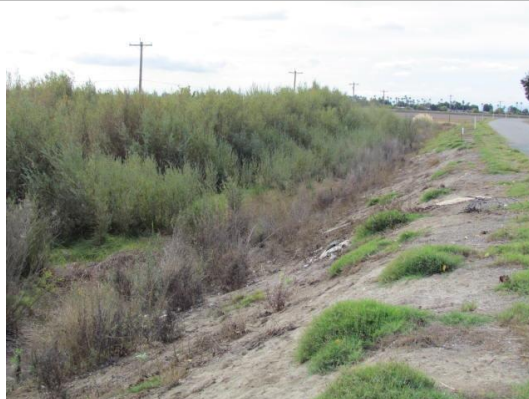
Photo 3 of 5 : SP_2017_RD0563_210_90_20170313_00089.jpg

Looking south at dense vegetation on landside toe. (2012 Fall Inspection)

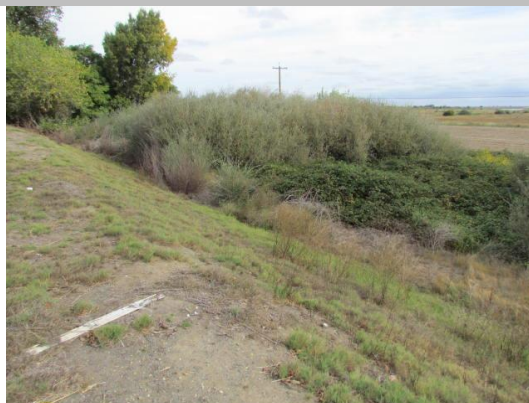
Photo 4 of 5 : SP_2017_RD0563_210_90_20170313_00090.jpg

Looking northeast at dense vegetation on landside toe. (2012 Fall Inspection)

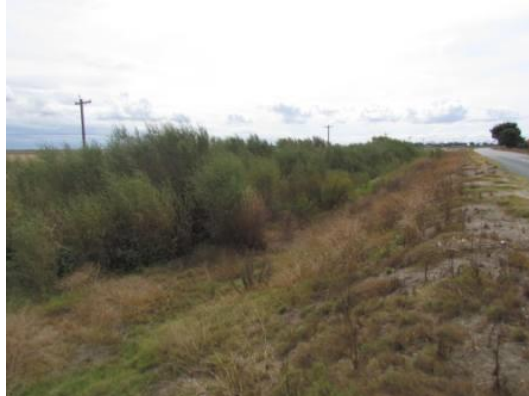
Photo 5 of 5 : SP_2017_RD0563_210_90_20170313_00091.jpg

Looking southwest at dense vegetation on landside toe.

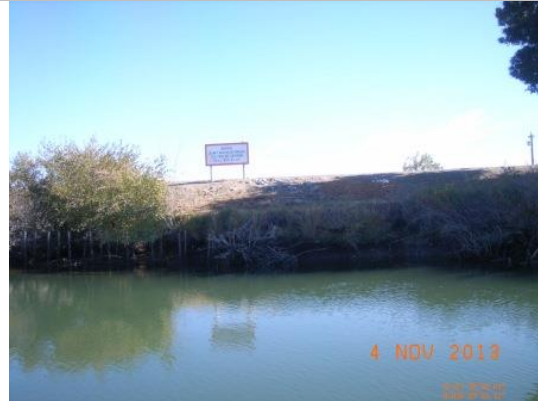
Photo 1 of 1 : SP_2017_RD0563_210_13_20170313_00014.jpg

| 1997 - Pockets of erosion into the levee toe. 1999 - Minor rock riprap and willow bundles place in a couple of spots. 2001 - Staked, low fascine walls at bankline. 2003 - Small unprotected pockets still eroding. 2004 - Numerous brush boxes, some falling apart, some with new bundles. 2005 - Some new brush boxes installed; some boxes are empty. Levee slope and banks still look bad with pocket scallops into the levee slopes. 2011 - Erosion continues and the number of pockets is increasing. 2013 - Some of the downstream end was repaired by the RD. 2015: Last observed in 2013. [2015 Site ID: GEO_4-3_L] | | | | | |

USACE 2013 Photo #1

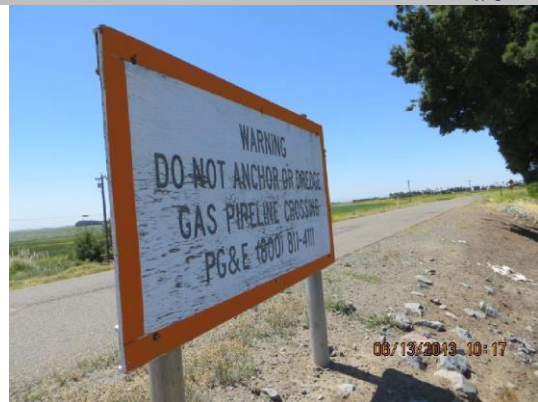
Photo 1 of 2 : UCIP_SP_2017_16263_27401.jpg

| FS_ID:16263 DS_ID:23973 EP_NO: N/A Repair Type: Non-Urgent Crossing Status: Indicator Found UCIP Comments: Need to determine disposition of all gas lines in this immediate area. FIELD_STRUCT_DESC: Gas line marker on WS shoulder. Pipe through the levee at unknown depth below the crown. FS Date: 6/13/2013 | | | | | |

Sign on WS shoulder.

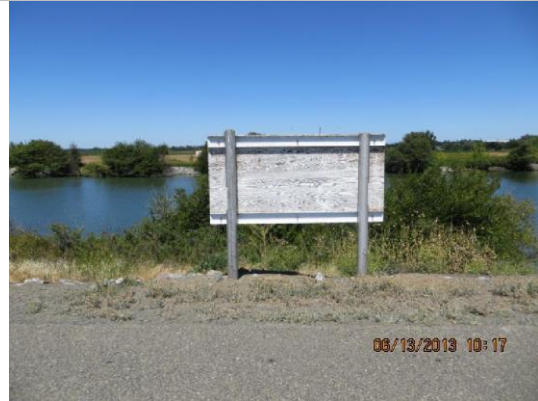
Photo 2 of 2 : UCIP_SP_2017_16263_27400.jpg

| FS_ID:16263 DS_ID:23973 EP_NO: N/A Repair Type: Non-Urgent Crossing Status: Indicator Found UCIP Comments: Need to determine disposition of all gas lines in this immediate area. FIELD_STRUCT_DESC: Gas line marker on WS shoulder. Pipe through the levee at unknown depth below the crown. FS Date: 6/13/2013 | | | | | |

Sign on WS shoulder.

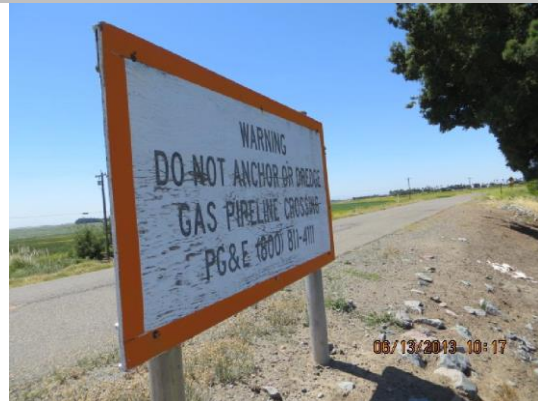
Photo 1 of 2 : UCIP_SP_2017_16265_27407.jpg

| FS_ID:16265 DS_ID:23974 EP_NO: N/A Repair Type: Non-Urgent Crossing Status: Found UCIP Comments: Need to determine disposition of all gaslines in this immediate area. FIELD_STRUCT_DESC: Gas line marker on WS shoulder. Pipe through the levee at unknown depth below the crown. FS Date: 6/13/2013 | | | | | |

Sign on WS shoulder.

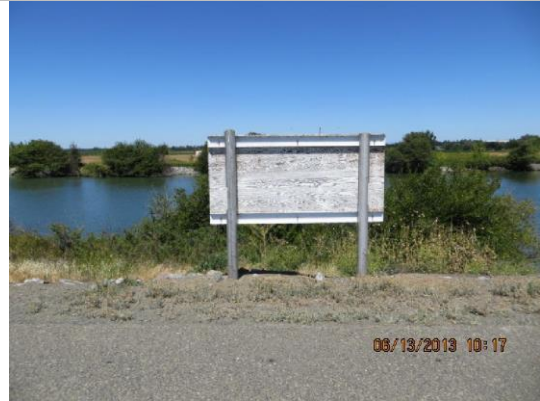
Photo 2 of 2 : UCIP_SP_2017_16265_27406.jpg

| FS_ID:16265 DS_ID:23974 EP_NO: N/A Repair Type: Non-Urgent Crossing Status: Found UCIP Comments: Need to determine disposition of all gaslines in this immediate area. FIELD_STRUCT_DESC: Gas line marker on WS shoulder. Pipe through the levee at unknown depth below the crown. FS Date: 6/13/2013 | | | | | |

Sign on WS shoulder.

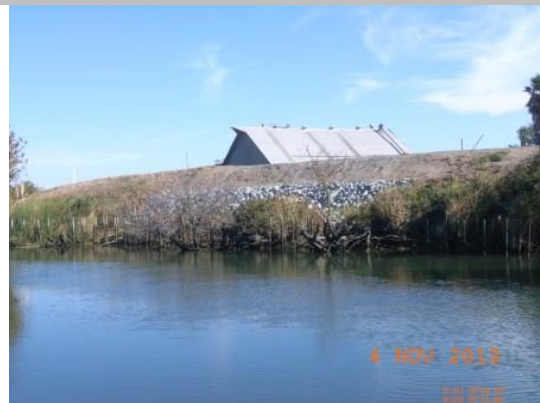
Photo 1 of 1 : SP_2017_RD0563_210_40_20170313_00033.jpg

| 1997 - Pockets of erosion into the levee at the water line. Alders are being undercut and rotating out into the channel. Damaged rock at upstream end. 2000 - New minor erosion. 2001 - Staked low fascine walls at bankline. 2002 - New "Brush Boxes" along the bank toe. 2003 - New erosion pockets in the middle of the site. 2005 - Some new bundles in the brush boxes. 2011 - Site upgraded to CRITICAL. Significant new erosion. Sites 3.6, 3.7, 3.71, and 4.0 were combined. 2012 - Rock has been placed in some of the erosion pockets since last year, however site remains critical. 2013 - Site no longer critical. The worst pockets were filled with rock by the local RD. 2015: Last observed in 2013. [2015 Site ID: GEO_3-8_L] | | | | | |

USACE 2013 Photo #1

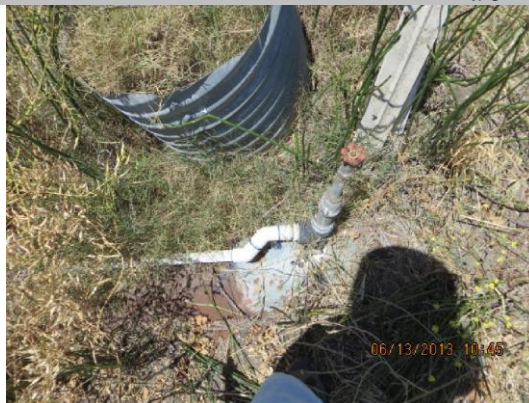
Photo 1 of 3 : UCIP_SP_2017_14988_24670.jpg

| FS_ID:14988 DS_ID:20160 EP_NO: 9145 Repair Type: Non-Urgent Crossing Status: Found UCIP Comments: Good candidate for video inspection. Erosion in levee adjacent to pipe. FIELD_STRUCT_DESC: 2 of 2: 16-inch pipe through levee 3.0 feet below crown. 14-inch steel irrigation siphon sleeved through the 16-inch pipe with annular space grouted. Air vent/filler pipe on LS shoulder with and a slide gate in a 48-inch steel standpipe on the LS toe (ABO No. 9145, 1973). Originally included in the 1954 O&M manual. FS Date: 6/13/2013 | | | | | |

air vent/filler pipe on LS shoulder.

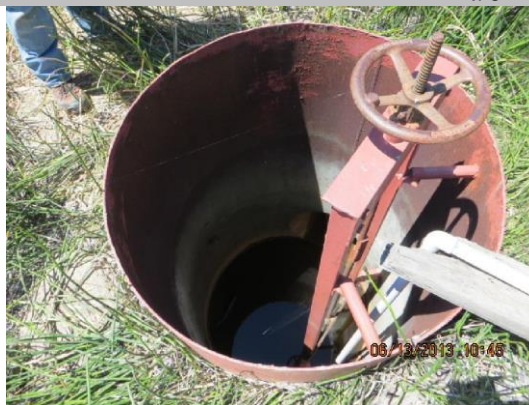
Photo 2 of 3 : UCIP_SP_2017_14988_24669.jpg

Slide gate in steel riser on LS toe.

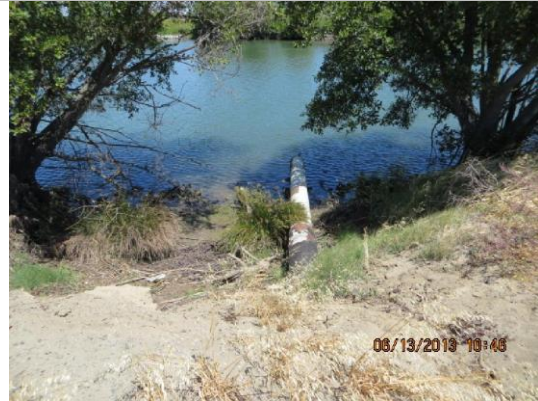
Photo 3 of 3 : UCIP_SP_2017_14988_24668.jpg

| FS_ID:14988 DS_ID:20160 EP_NO: 9145 Repair Type: Non-Urgent Crossing Status: Found UCIP Comments: Good candidate for video inspection. Erosion in levee adjacent to pipe. FIELD_STRUCT_DESC: 2 of 2: 16-inch pipe through levee 3.0 feet below crown. 14-inch steel irrigation siphon sleeved through the 16-inch pipe with annular space grouted. Air vent/filler pipe on LS shoulder with and a slide gate in a 48-inch steel standpipe on the LS toe (ABO No. 9145, 1973). Originally included in the 1954 O&M manual. FS Date: 6/13/2013 | | | | | |

Pipe visible on WS toe.

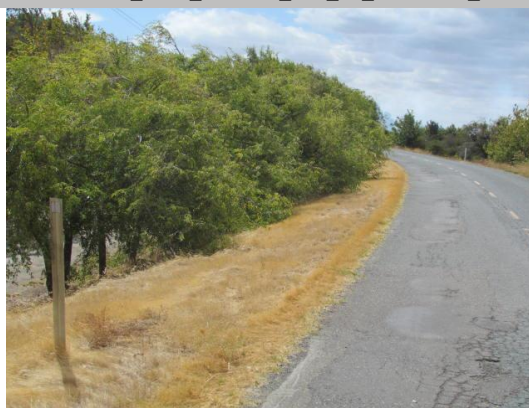
Photo 1 of 1 : SP_2017_RD0563_210_31_20170313_00026.jpg

Looking southeast at untrimmed trees on landward slope and toe.

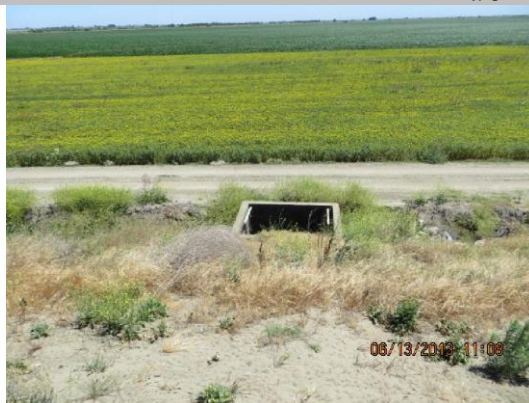
Photo 2 of 3 : UCIP_SP_2017_16292_27452.jpg

| UCIP Comments: Appears abandoned and should be done so properly. Slide gate broken. | | | | | | |

Concrete distribution box at LS toe.

Broken slide gate in 7'X9' concrete distribution box on LS toe.

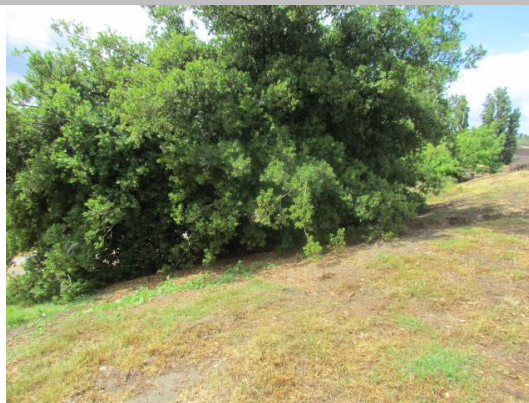
Photo 1 of 1 : SP_2017_RD0563_210_98_20170313_00099.jpg

Looking southeast at untrimmed trees on landward slope.

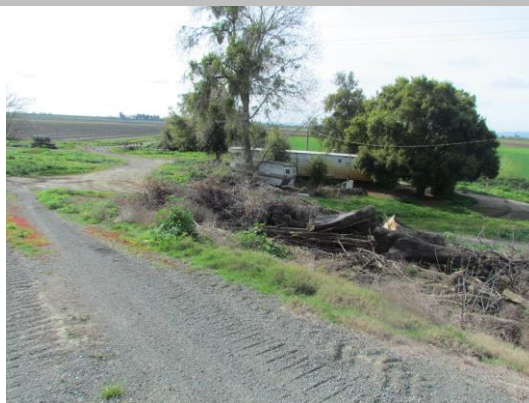
Photo 1 of 3 : SP_2017_RD0563_210_73_20170316_00260.jpg

| Large pruning pile on landward toe. | | | | | |

Looking east at large pruning piles at landward toe. (Spring 2017)

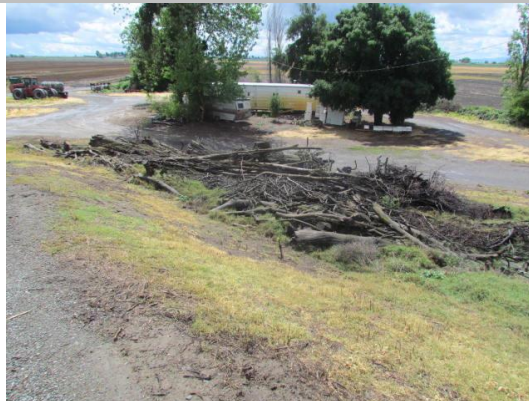
Photo 2 of 3 : SP_2017_RD0563_210_73_20170313_00057.jpg

Looking east at prunings at landward toe. (Spring 2015)

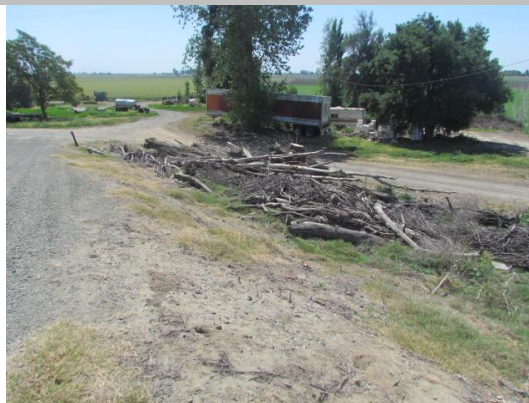
Photo 3 of 3 : SP_2017_RD0563_210_73_20170313_00058.jpg

| Large pruning pile on landward toe. | | | | | | |

Looking east at prunings on landward slope. (Spring 2013)

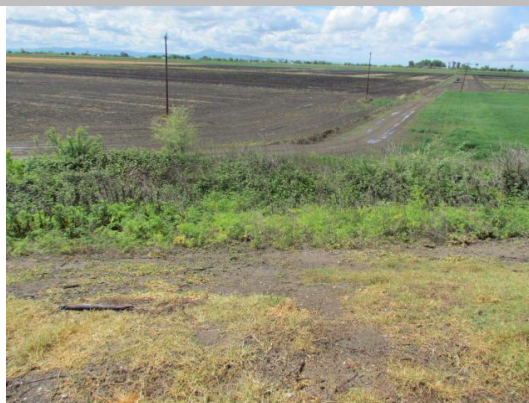
Photo 1 of 1 : SP_2017_RD0563_210_769_20170313_00153.jpg

Looking east at dense vegetation at landward toe. (Spring 2015)

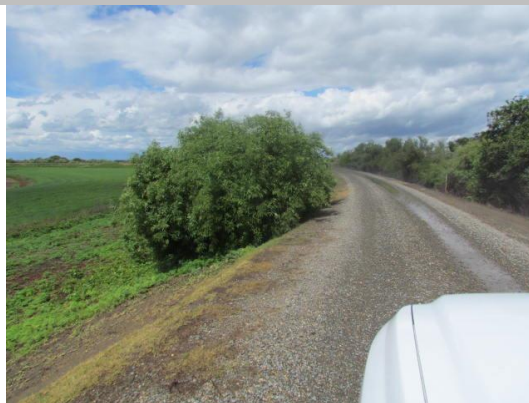
Photo 1 of 1 : SP_2017_RD0563_210_36_20170313_00030.jpg

| Vegetation blocking view of levee slope. | | | | | |

Looking south at elderberry on landward slope.

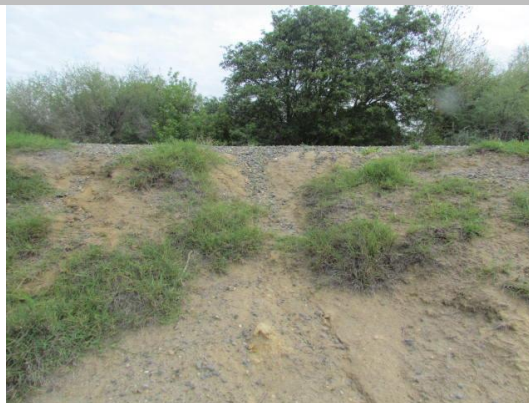
Photo 1 of 2 : SP_2017_RD0563_210_99_20170313_00100.jpg

| Finger erosion on landward shoulder and slope. | | | | | |

Looking west at minor erosion on landward shoulder and slope.

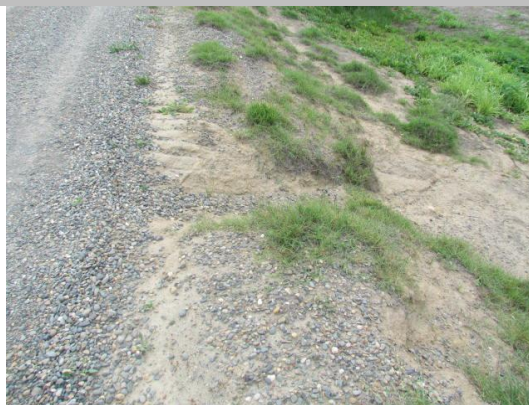
Photo 2 of 2 : SP_2017_RD0563_210_99_20170313_00101.jpg

Looking north at minor erosion on landward shoulder and slope.

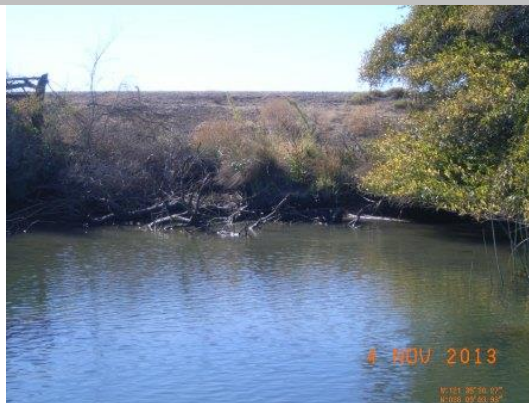
Photo 1 of 1 : SP_2017_RD0563_210_41_20170313_00034.jpg

| 1997 - Erosion pockets into the toe of the levee. 2001 - Staked low fascine walls at the bankline. 2004 - Numerous "Brush Boxes." 2005 - Some new bundles in the brush boxes. 2012 - Site extended downstream to account for new bank sloughing. 2013 - Some rock added to the upstream end by the local RD. 2015: Last observed in 2013. [2015 Site ID: GEO_2-5_L] | | | | | |

USACE 2013 Photo #1
